Timing The Camshafts On The LT5 Engine

Marc Haibeck

27-Jul-17

A Detailed Description of How to Check and Adjust the Camshaft Timing on the LT5 Engine

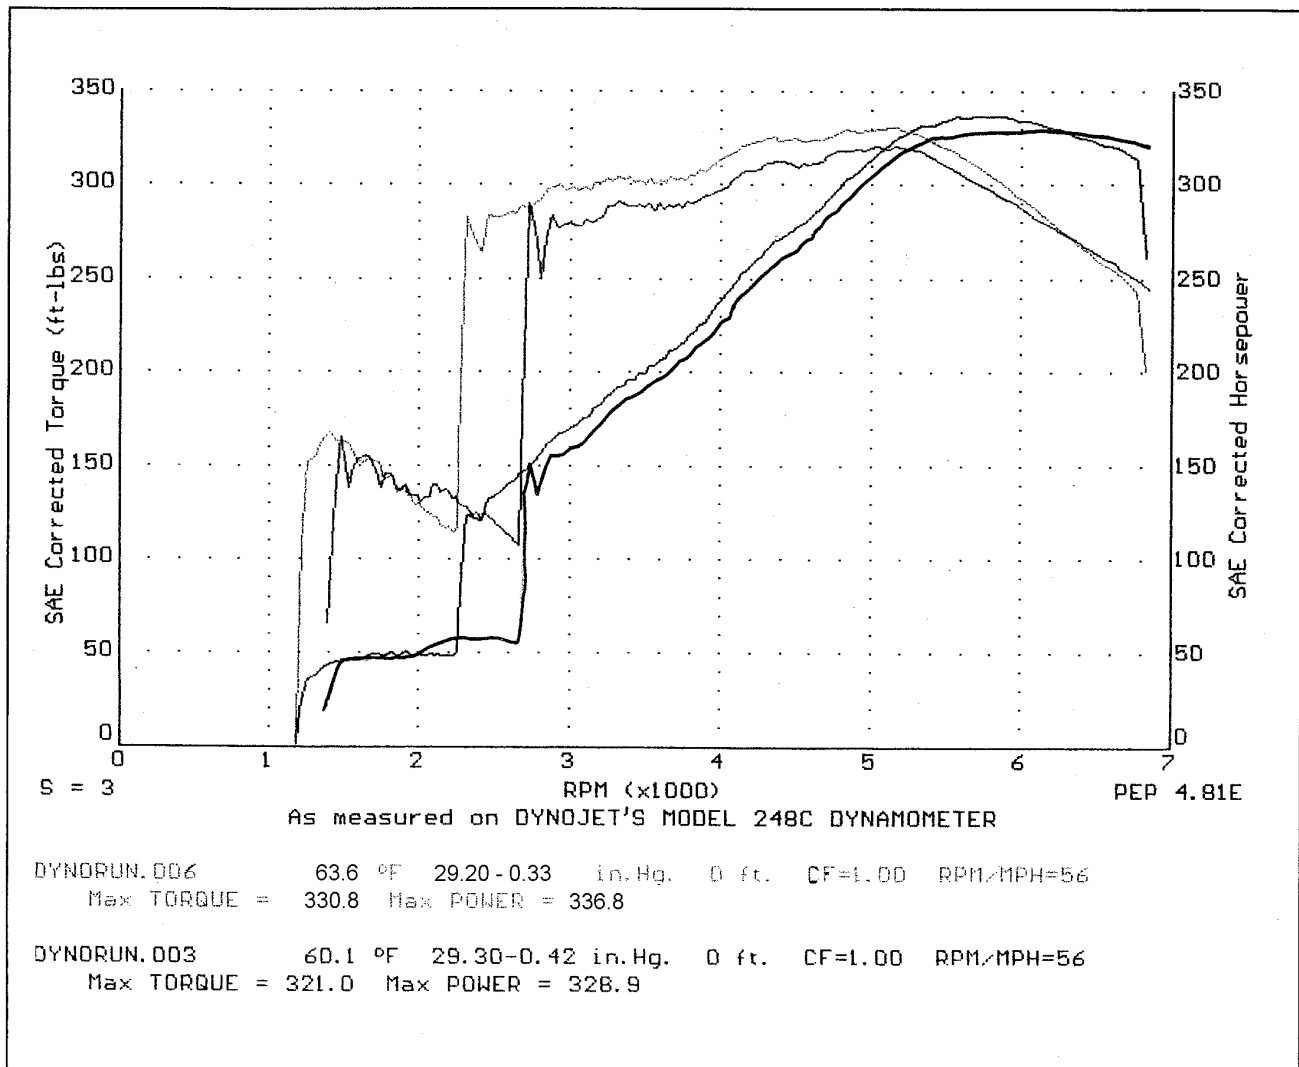
It's best to have the engine on an engine stand when timing the camshafts. The camshaft timing was checked and adjusted on my '93 engine with 33K miles. Preliminary to the check, a baseline measurement was performed on a DynoJet™ chassis dyno. The camshaft timing was found to be out of specification in two ways. The right camshafts were retarded by about four degrees. This would be expected from normal wear as the drive chains stretch and the right upper chain guide wears down. The left intake camshaft was similarly out of specification. Secondly, and somewhat surprisingly, the left exhaust camshaft was found to be positioned correctly. This camshaft was apparently installed four degrees out of phase with respect to the other camshafts when the engine was assembled at the factory. The three camshafts that were out of specification were adjusted to the original engine specification.

The engine was reassembled with no other changes. The DynoJet machine was revisited. As illustrated by the dyno chart, the peak torque increased by about 10 and the peak horsepower increased by about eight. However, the improvement in the area under the curve was the most significant improvement. The torque and horsepower improvements span approximately 4000 RPM. Behind the throttle, in normal street driving, I'm constantly aware of the increased torque. It's interesting to observe how the horsepower curves cross at 6300 RPM. In an engine of this type, retarded camshaft timing will normally favor the power output at the higher engine speeds. For most engines, as the timing chain(s) wear, the output tends to become peaky. Returning to the designed camshaft positioning reduced the power output from 6300 to 7000 RPM. However, this is offset a huge amount, by the increased output from 2500 RPM to 6300 RPM. The average power output, or area under the curve, is much more important in terms of acceleration than the peak power. The average torque increased by 13 and the average horsepower increased by 5. Previous to the adjustment, this engine was usually shifted at 7000 RPM for best acceleration. The ideal shift point has moved to 6800 RPM, which is probably good for the engine in the long run.

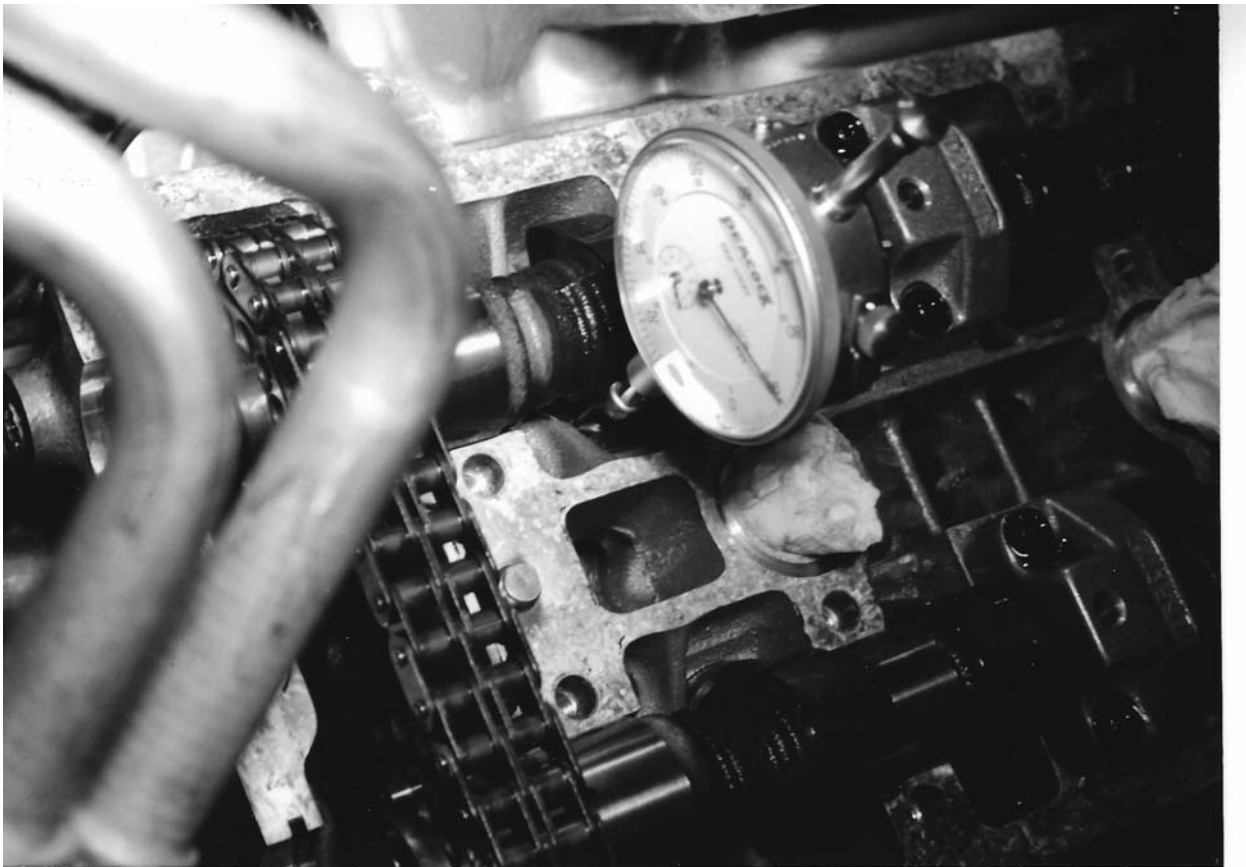
For the right bank, mount the dial indicator on the exhaust camshaft on cylinder number six. Since cylinder number six is one cycle behind cylinder number one, the timing readings on the timing wheel can be used just as if the measurements were being made on cylinder number one. Use the primary lobe, because it has less duration. Thus it will make larger swings on the dial indicator near TDC. Fabricate a bracket that will mount the dial indicator to a camshaft cover bolt hole. The dial indicator will need an offset tip in order to probe the lifter in its close proximity to the camshaft lobe. The picture shows a typical setup for the dial indicator. It's shown on cylinder number one.

Record the dial indicator reading at full lift. Use the full lift measurement minus .010 inch as a checking height. A typical checking measurement for an exhaust lobe would be: Reading from the timing dial, before TDC, at .010" before full lift, $90 + 34 = 124$ degrees. Pass full lift. Read from full lift -.010". 87 degrees. $124 + 87 / 2 = 105.5$ degrees. Since the exhaust centerline should be 110 degrees, this camshaft is 4.5 degrees retarded.

To increase the exhaust camshaft centerline number, rotate the camshaft clockwise. Carefully hold the camshaft with the hex on the end and simultaneously turn the sprocket bolt loose without turning the camshaft. Adjust the camshaft; .001" on the dial gage equals approximately one degree of camshaft rotation. In the example above turn the camshaft clockwise about .004" to get to 110 degrees. Snug the bolt to about 60 lb. ft. Rotate the camshaft one turn to check the results of the adjustment. I aim for a final position at 111 degrees +/- .5 degree.

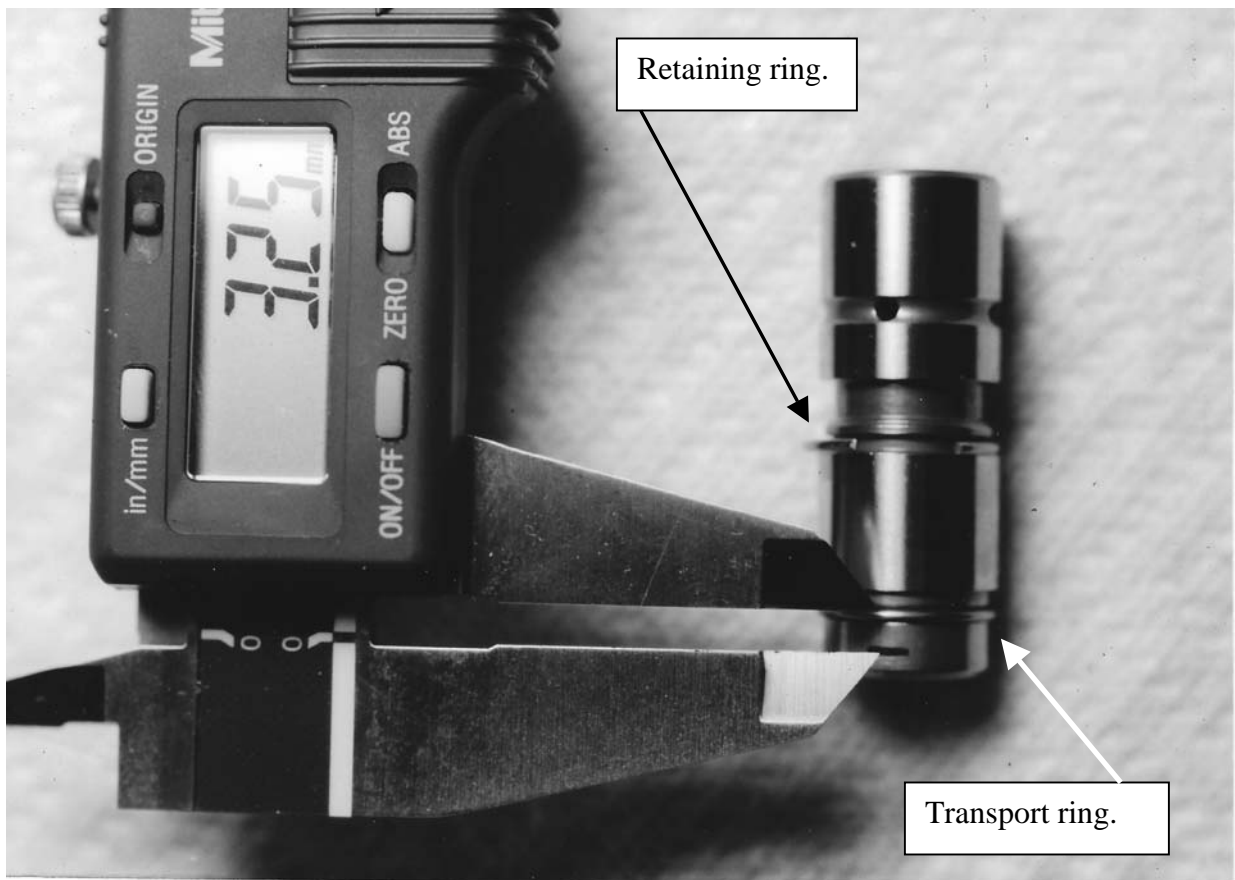
Place the forked end of the tensioner assembly horizontally in a vise. Pull out on the piston until a slot near the top of the piston is uncovered. Then use a large screwdriver to carefully pop the piston out. Be prepared for about one quarter of an ounce of oil to emerge. When unlocked, the larger retaining ring that can be seen in the picture stops the piston.

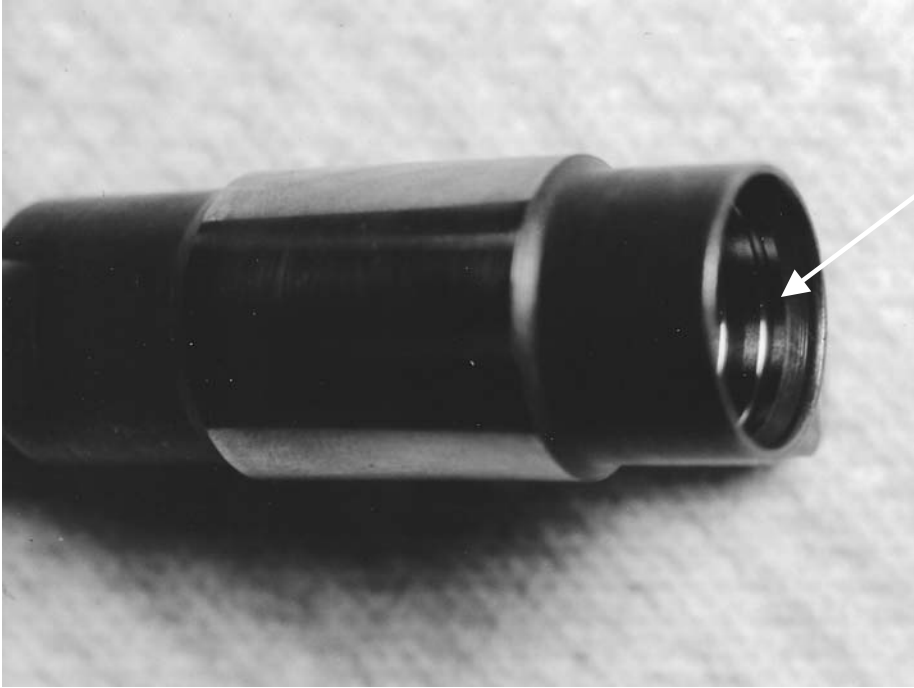
The transport ring groove.

Lock the tensioner in the compressed, or Transport Position, by engaging the small retaining ring that is found on the end of the piston, into the groove in the body of the tensioner. The picture above shows the transport retaining ring. The picture below shows the groove in the body that engages with the transport locking ring.

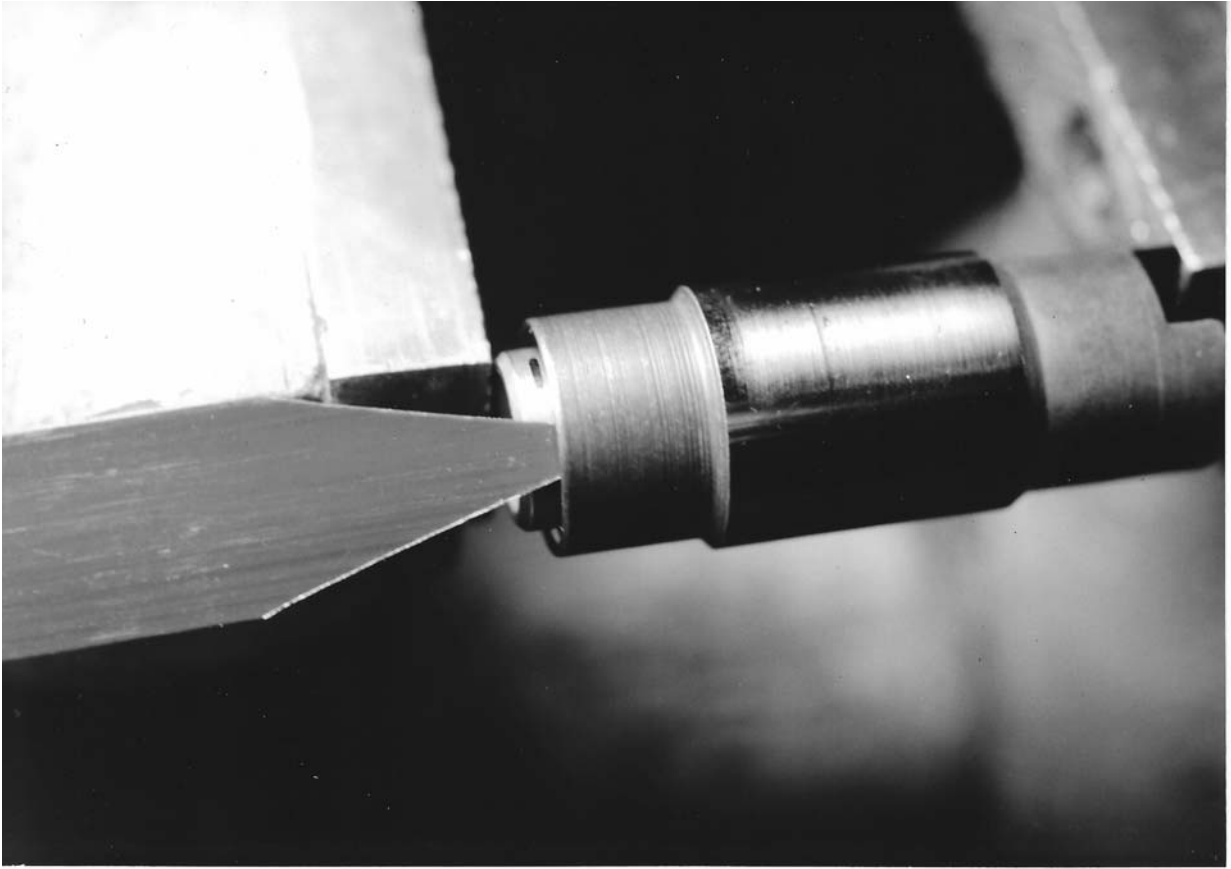
To compress the tensioner, first make sure that the larger retaining ring is in the piston's small groove as shown in the picture of the tensioner piston. Lightly oil the piston and place it back in the body. Use a vise to compress the assembly. It will make a clicking sound as the large retaining ring passes the lower stop grooves in the body. Compress it until the piston bottoms. The transport ring will be located 3.5 mm down into the tensioner body. Finally, push down on the transport retaining ring with a thin pointy tool as shown in the picture below. This expands the ring into the groove in the tensioner body.
