## An Interesting Tripple Fault Diagnostic Adventure

Marc Haibeck

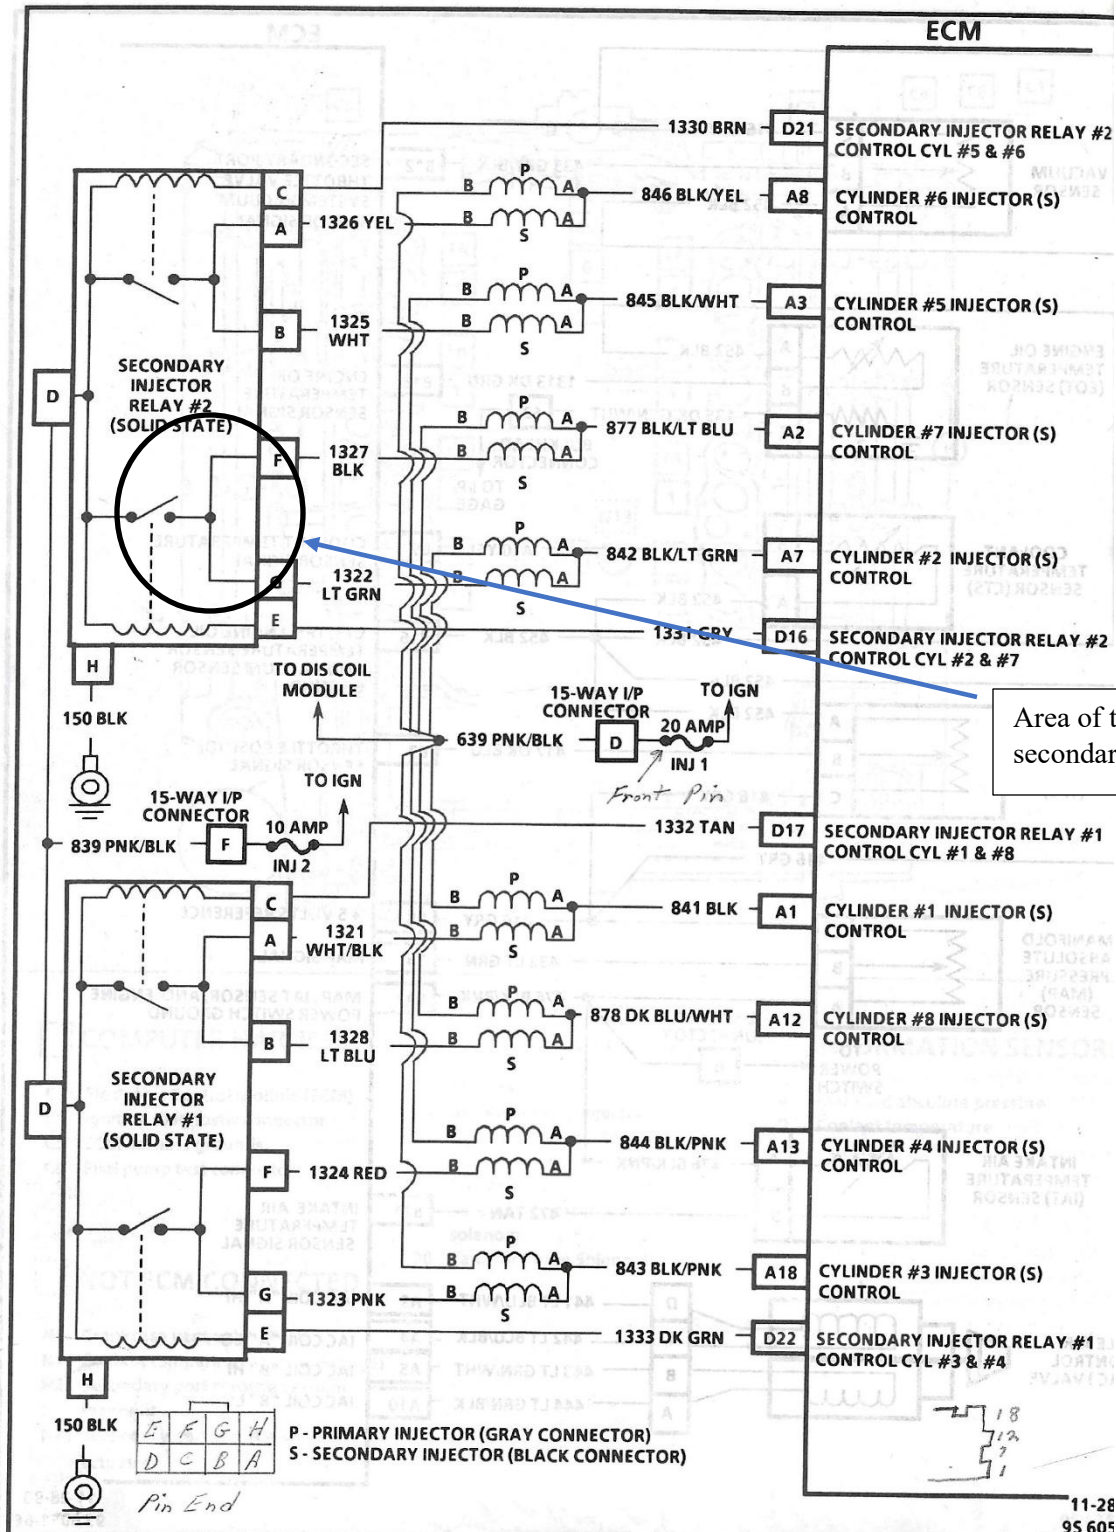
Figure A-4 - ECM Wiring Diagram 5.7L (VIN J) "Y" Carline (2 of 8)

GM depicts it logically as a pair of mechanical relays. I cut the box open to see if anything was obviously wrong with it. In reality it is a complex electrical circuit. It passed physical inspection. Since there were so many diodes, and diodes are easy to test with an ohm meter, checked them. A diode conducts current in one direction only. The battery in the ohm meter will forward bias the diode and the meter will show low resistance. If the meter leads are reversed the voltage applied to the diode is reversed and it will show very little current flow/resistance.

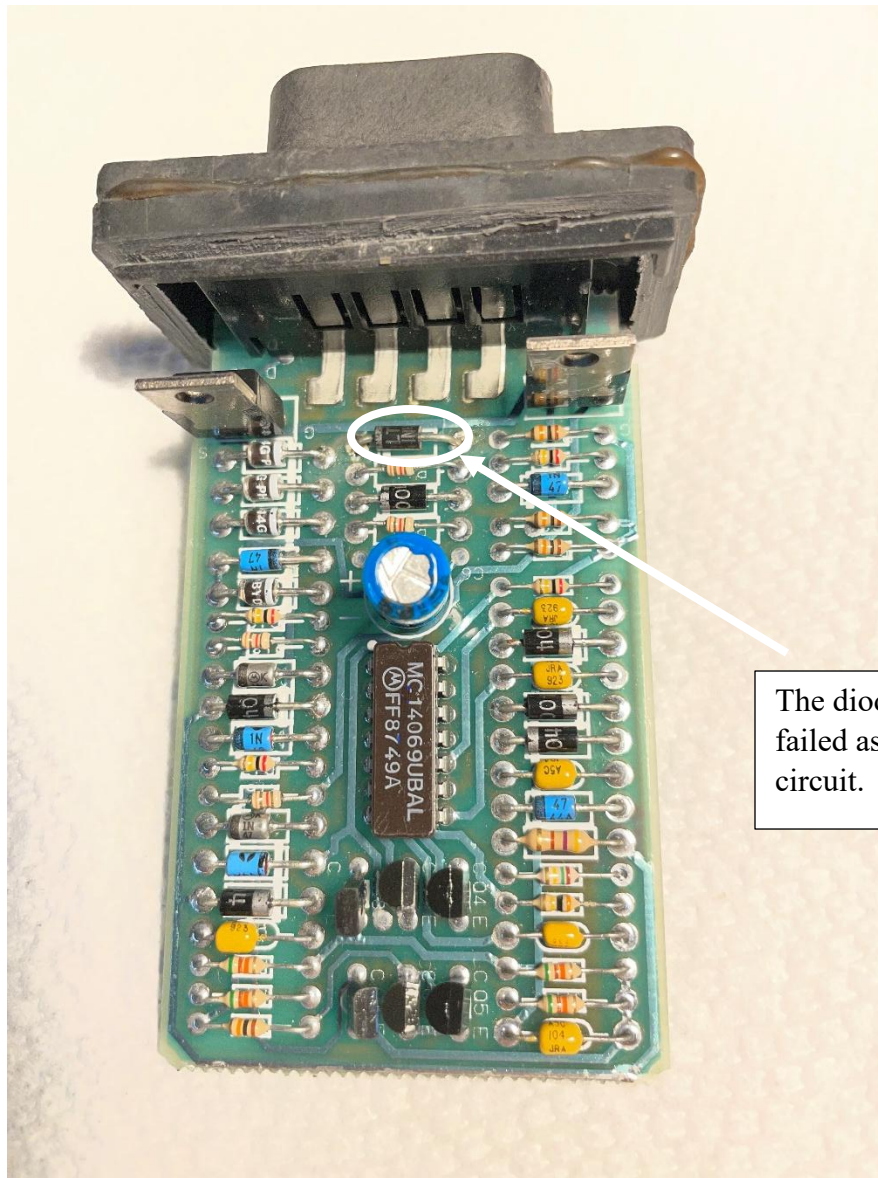
I observed that the diode pointed to in the picture, had no current flow in both directions. It could not be forward biased. It's a common 1N4002 diode. I replaced it, and tested the secondary relay in a car. The secondary relay now has a new life!

The diode that failed as open circuit.
