Diagnosing and Understanding Starting Problems on the ZR-1

Marc Haibeck

28-Sep-13

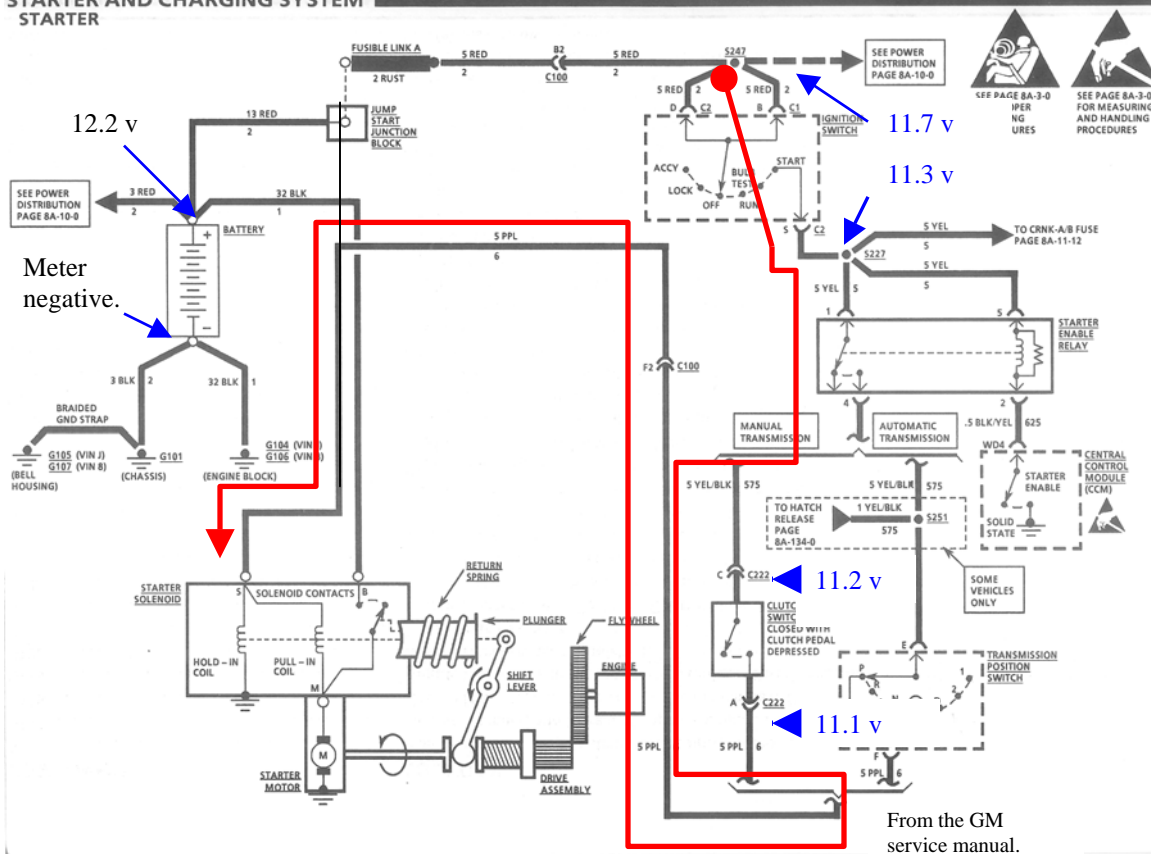
'90 to '92

These voltage measurements were made with a starter that had a silent no cranking problem. The current is 28 to 30 amps when the ignition key is turned to start and the starter is silent when it should be cranking. This is the solenoid pull-in current. The current flow is shown in red. Typical voltages are marked in blue. For these measurements the voltage at the battery terminals was 12.2 volts. The voltage differences between points are voltage drops. The meter was connected between the points shown and the negative battery terminal. If the starter works correctly and the plunger pulls in to run the motor the current will reduce to the solenoid hold-in current of nine to 10 amps.

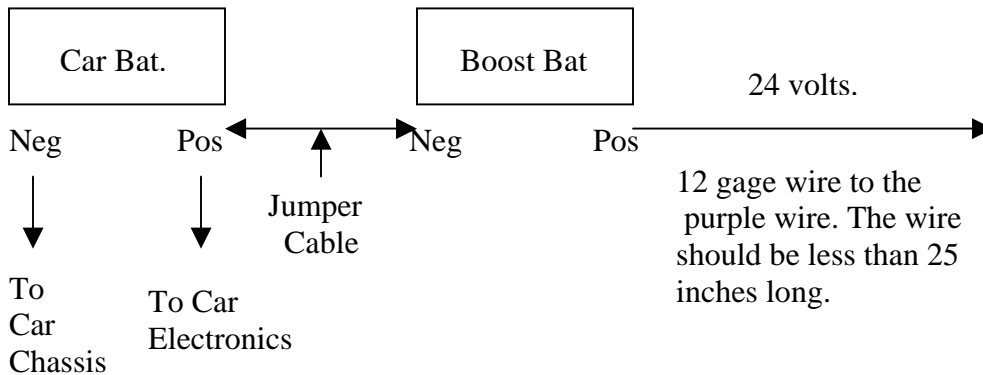
I have been able to revive two silent starters. One was on a car that was stored in a climate controlled room and not started for 10 years. Another was on a car that was stored in a cold garage and not started over a Chicago winter. Both cars continued on for many years without a further starter problem. I suspect that these cars had high plunger friction after the storage periods.

The plunger pull-in force can be doubled by applying 24 volts. Place a second battery in series with the car battery. Apply the 24 volts to the purple wire. Apply the current for one half second to prevent overheating the solenoid.

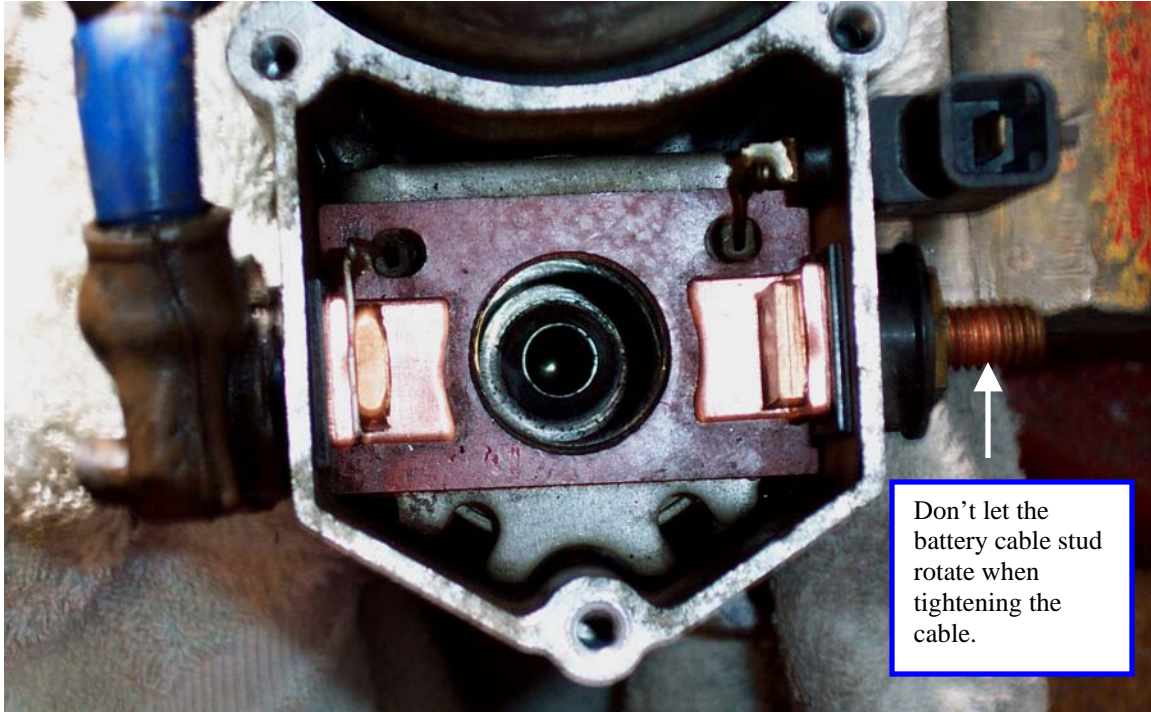
The battery terminal stud is sensitive to rotation. If it is rotated, the contact inside the solenoid will twist out of alignment. This can result in the plunger contactor making a connection on the corner of the contact rather than across the face. This can greatly shorten the life of the contact. Hold the battery cable stationary when tightening the nut to prevent rotation of the stud.

This is a picture of a solenoid with new contacts.

The contacts need to be level and square with the housing so that the plunger contact disk will lie evenly across them and make contact across the full faces of the contacts. The battery terminal stud does not have an anti-rotation stop. If it moves when tightening the cable it will lift the corner of the contact. Then the plunger will make a point contact rather than a full-face contact. This leads to shortened contact life and potentially a click and no cranking failure.

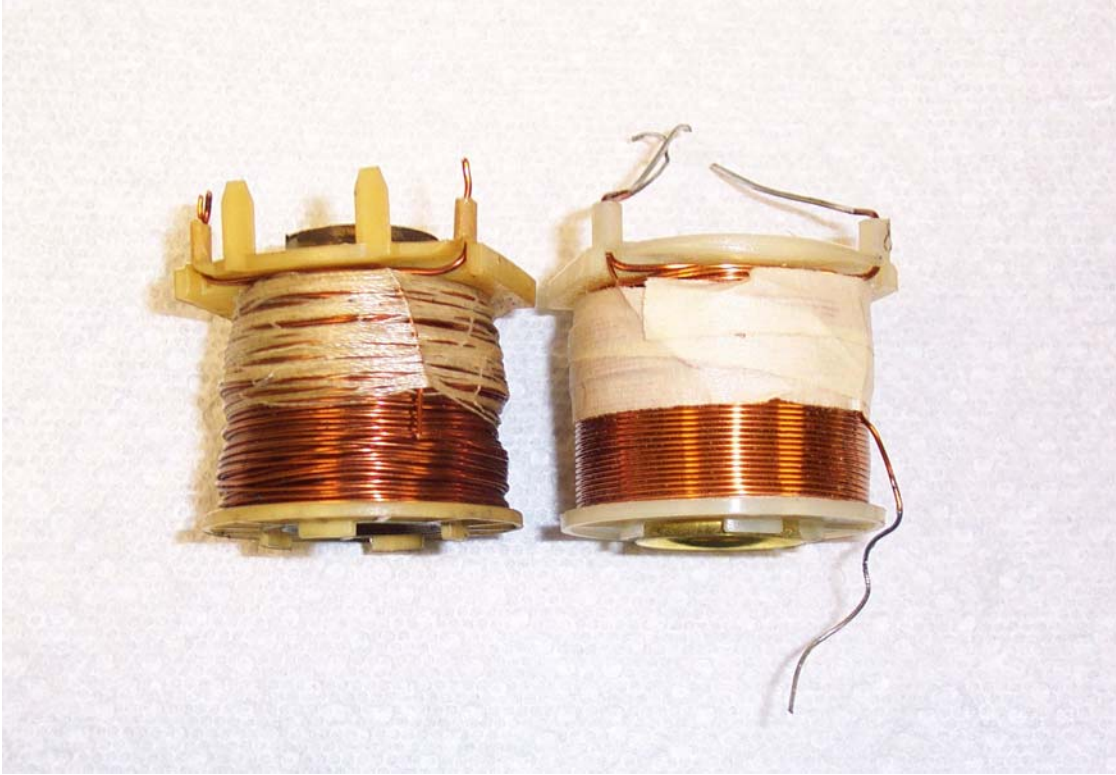
OE solenoid coils that I have seen are wound unevenly. The turns of wire cross over each other. This creates pressure points that might break down the shellac insulation coating on the wires and lead to a short circuit between turns. The insulating coating is further stressed by the oven like environment that the starter lives in. This could cause a silent no start condition.

The coil on the right is a new replacement part coil. It is smoothly wound. Maybe the smoothly wound coil is more durable.
