Finding and Fixing Oil leaks on the LT5 Engine

Marc Haibeck

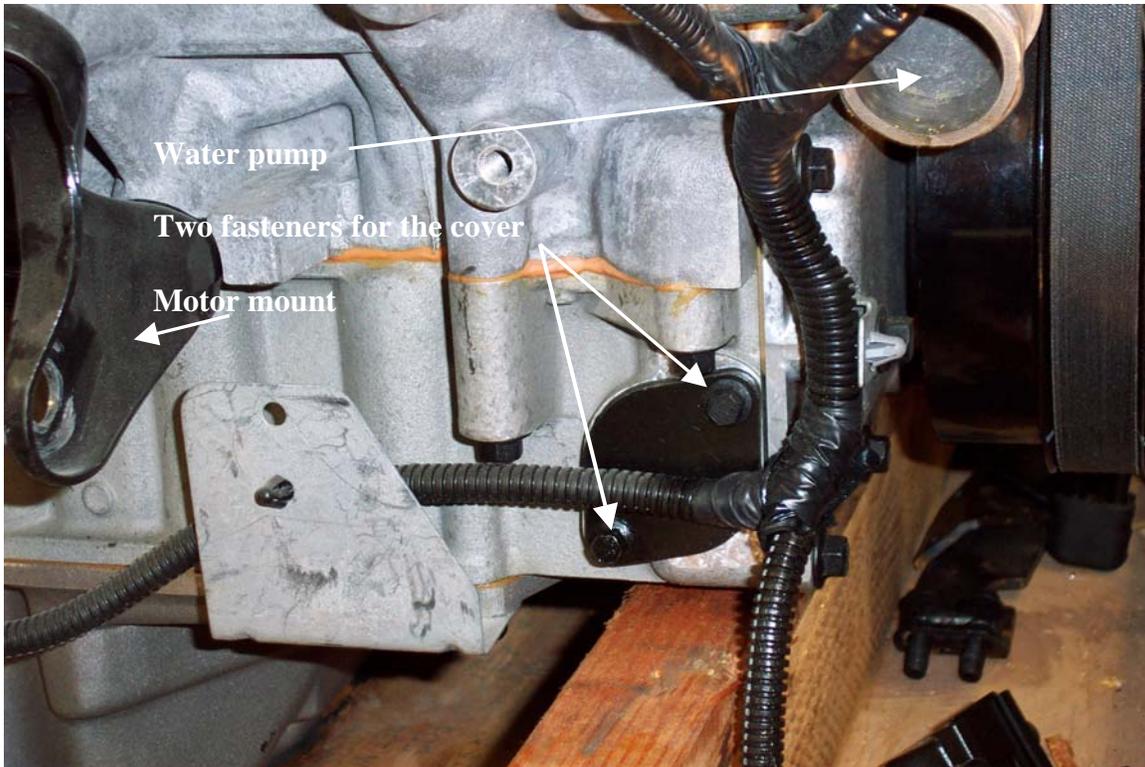
The Oil Pressure Regulator Cover

Often accompanying an oil pan gasket leak, is leakage from the little cover that is located on the right side front just above the oil pan flange.

The cover is often found to be loose. The little cover can't be seen when the engine is installed in the car. To reach it, I like to jack up the right front of the engine and reach down from the top. It's still difficult to see. I often tighten it by feel. The two fasteners with 8 mm heads need to be tightened.

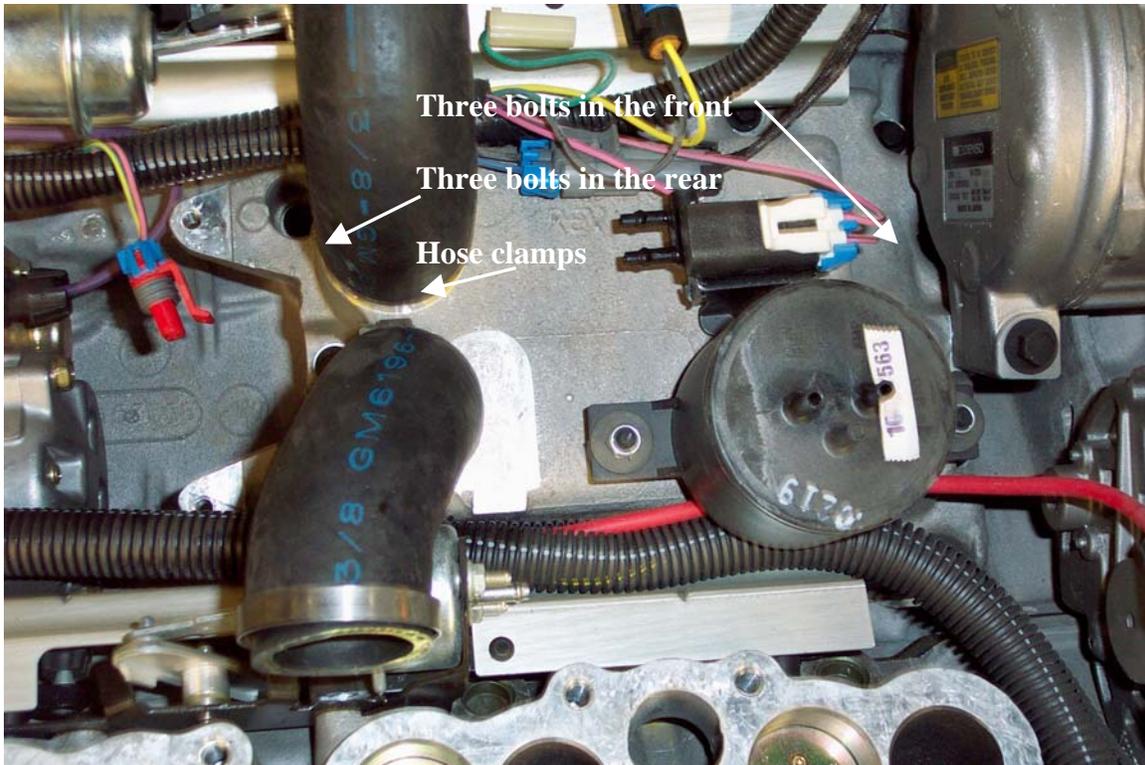
The Crankcase Breather Box

The crankcase breather box is located under the plenum. Leaks from the breather box and anything under the plenum will drip from the drain tube located behind the right side of the oil pan.

Leakage can be reduced significantly if the six easy to reach bolts are tightened. The lower ends of the crankcase breather hoses can leak. The hose clamps can be tightened.

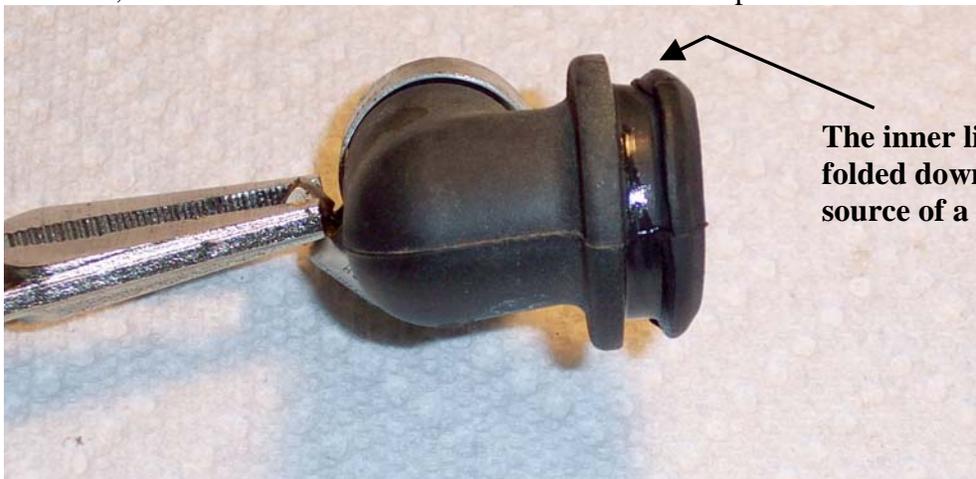
The PCV Vent Tube Grommet

If oil is found pooled under the injector housing it likely that the PCV vent tube grommet is leaking. About half of the grommets were installed incorrectly at the factory. When removed, it can often be found with a folded over inner lip.

The inner lip has been folded down. It's the source of a leak.

The grommet can be replaced. The GM part number is 14078872. Or it can be cleaned and sealed with gasket sealer.

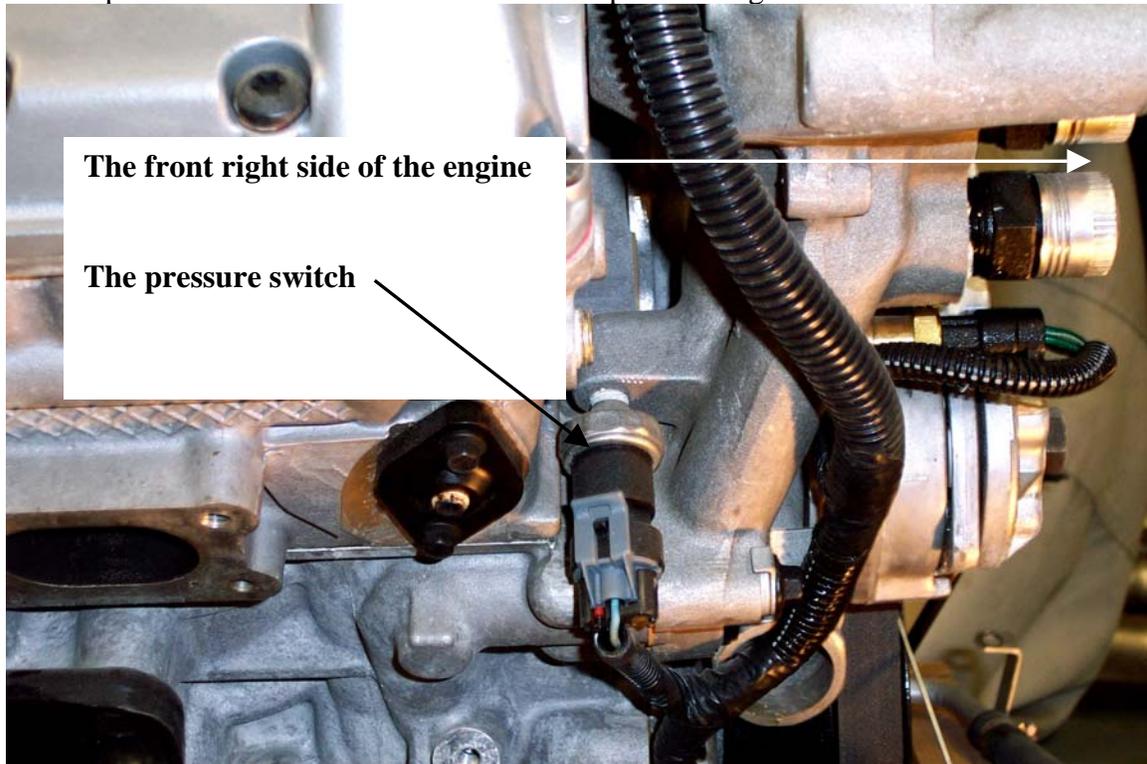
The Oil Pressure Switch

The oil pressure switch is located under the oil pressure regulator.

Oil from the switch connector can run down the cable and drip a few inches away, under the front pulley of the engine. To view the switch and service the switch, lift the right side of the engine.

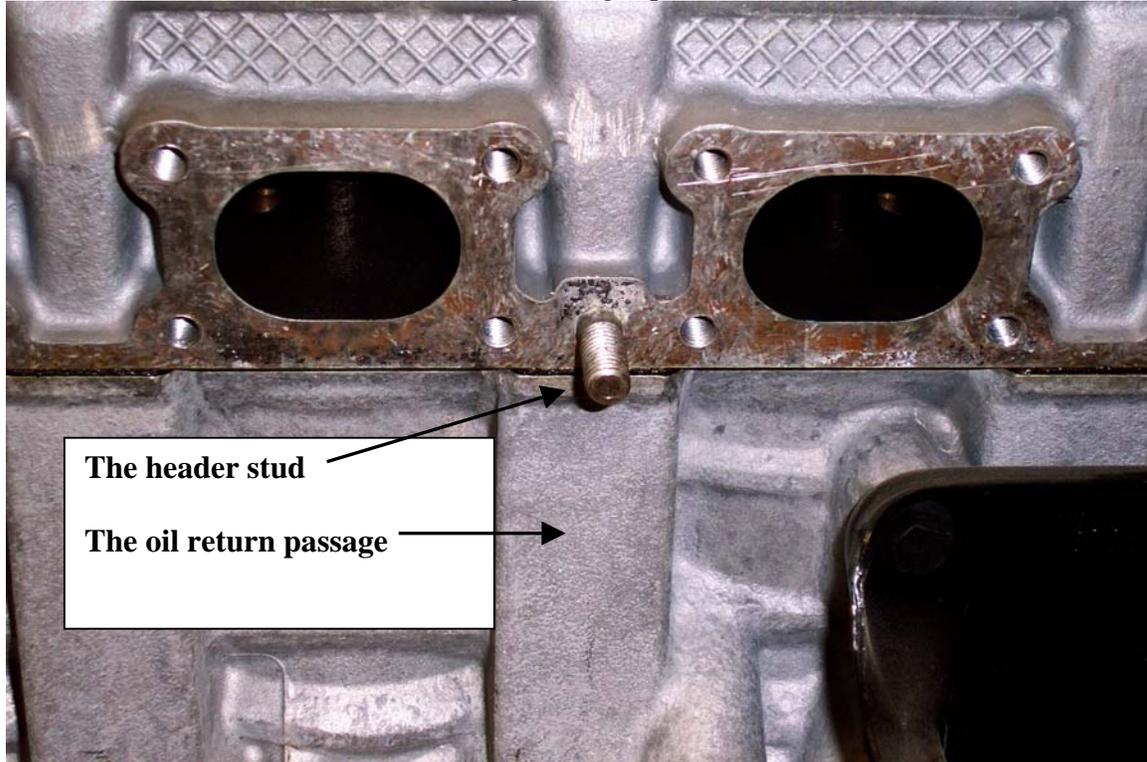
The Header Stud

The '90 – '92 engines have an exhaust manifold stud that screws into an oil return passageway. About 50% of the studs leak. When the leak is small there will be an acrid burning smell inside the car. Sometimes the stud leaks enough to drip on the floor. The factory used Loctite 620 retaining compound, but it does not seem to work too well. I recommend Loctite 565 sealer for a long lasting repair.
