Finding and Fixing Vacuum Leaks on the LT5 Engine

Marc Haibeck

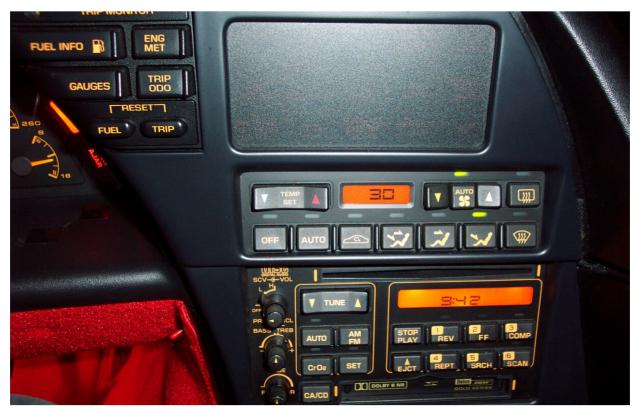
Checking the Accuracy of the Tachometer

• The displayed value x25 = the idle speed. 30 x 25 = 750. In this case the idle speed is 750 rpm.

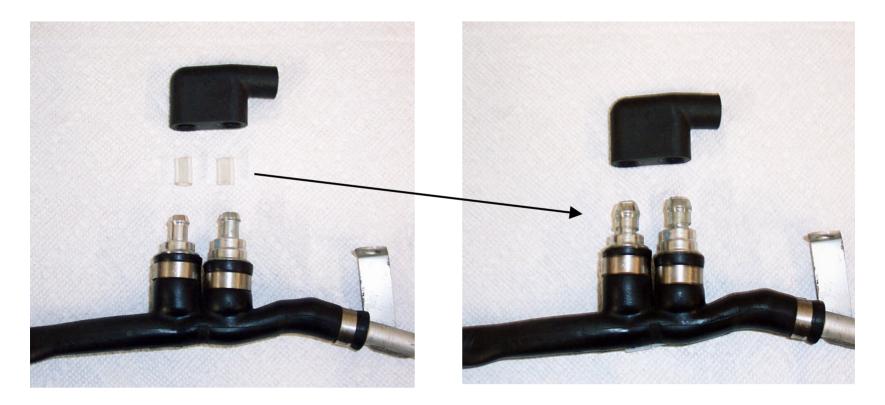
Source: PVC Valve Grommet

Install vinyl sleeves to repair it.

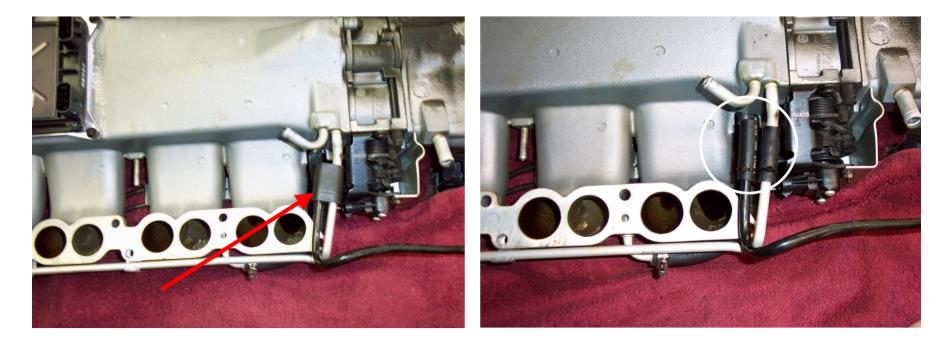
Source: Dual Vacuum Fitting

Only on a '90

Repair it with two stubs of 5/16" fuel line.

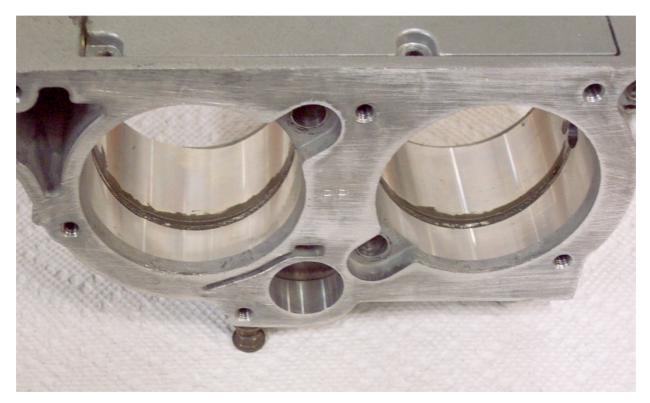
- Sticky secondary throttle plates
- Sticky primary throttle shaft

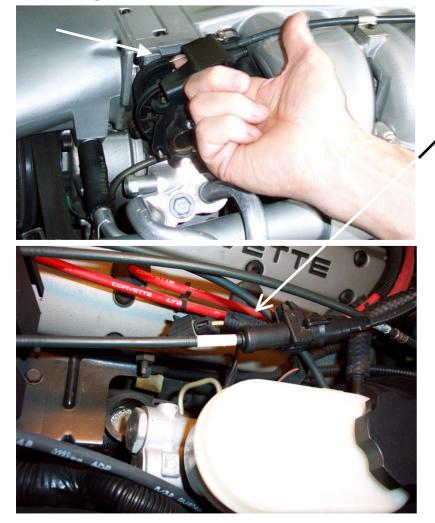
Wrap tape 1/8" from the adjuster.

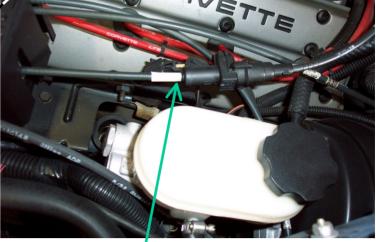
Press the button and shorten the cable one click. Note the smaller gap.

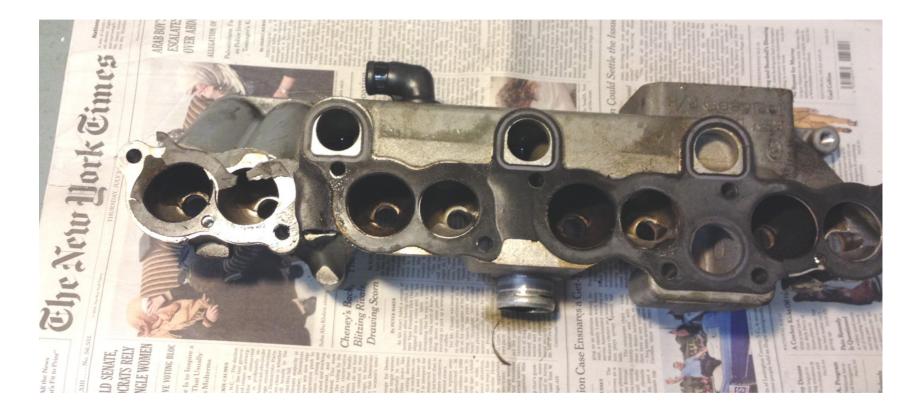
Source: Injector Housing Gasket

• More common on'93 and up cars

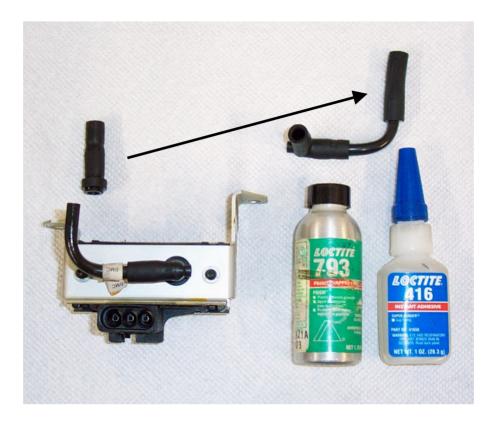
Source: MAP Hose

The connector can be reattached or replaced with 3/16" vacuum hose.

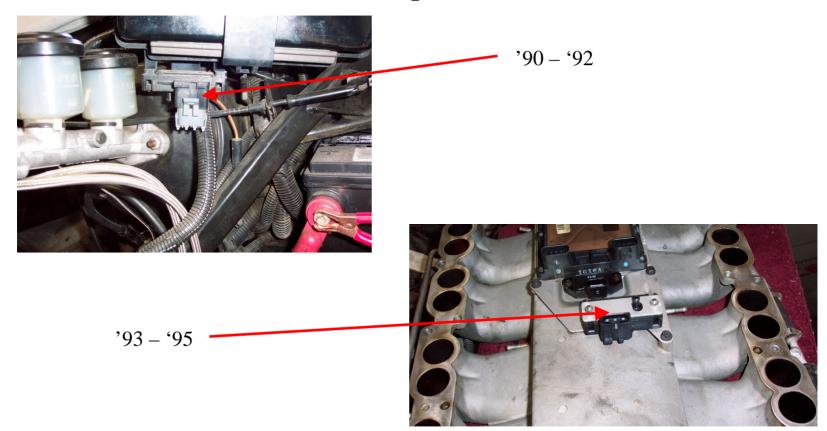
• Error 56. Electrical problem with the diagnostic vacuum sensor. This is not a vacuum problem.

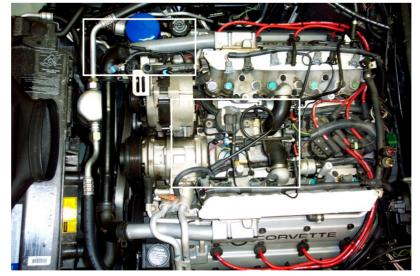
- Error 61. Vacuum is low. The error must persist for three seconds.
 - Low on power over 4000 rpm
 - Won't rev over 6000 rpm
 - Secondary vacuum pump does not run
 - Secondary vacuum pump runs all of the time

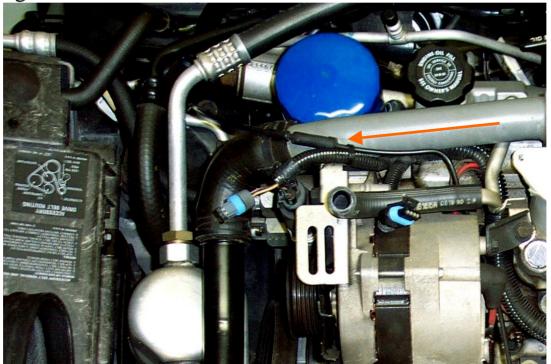
- Sources of leaks
 - Vacuum pump connector
 - The check valve
 - The secondary vacuum solenoid
 - Fitting on the vacuum reservoir

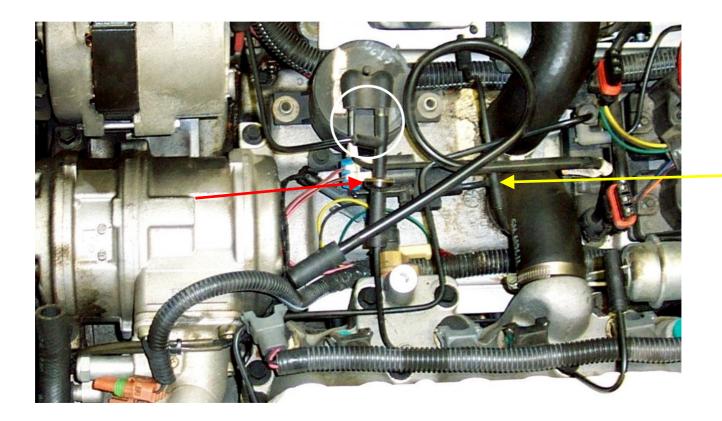
- Sources of leaks
 - Vacuum pump connector
 - The check valve. Red arrow.
 - The secondary vacuum solenoid. Yellow arrow.
 - Fittings on the vacuum reservoir. White circle.

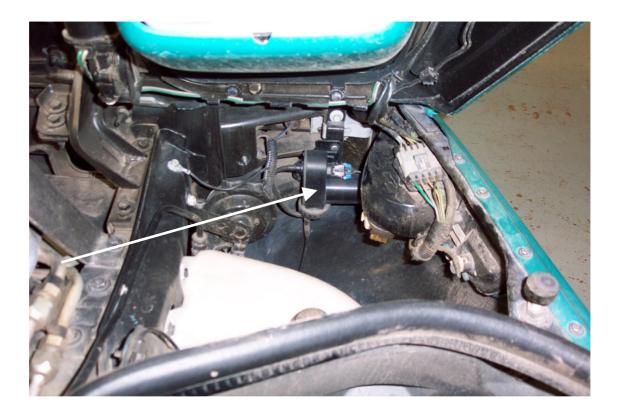
- Functional test of the system
 - The vacuum pump cycle time is your guide

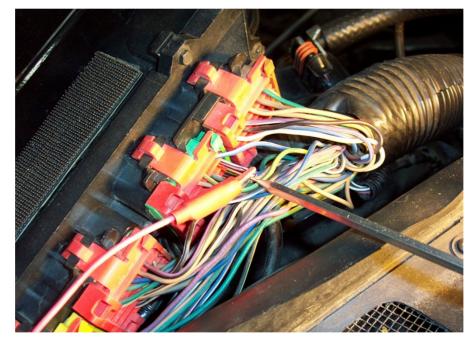
- Functional test of the system
 - The vacuum pump cycle time is your guide
 - Ground ECM pin C17 to open the secondary port vacuum solenoid which opens the secondary port throttles. The pump should be able to shut off for at least one second.
