Timing The Camshafts On The LT5 Engine

Marc Haibeck

27-Jul-17

A Detailed Description of How to Check and Adjust the Camshaft Timing on the LT5 Engine

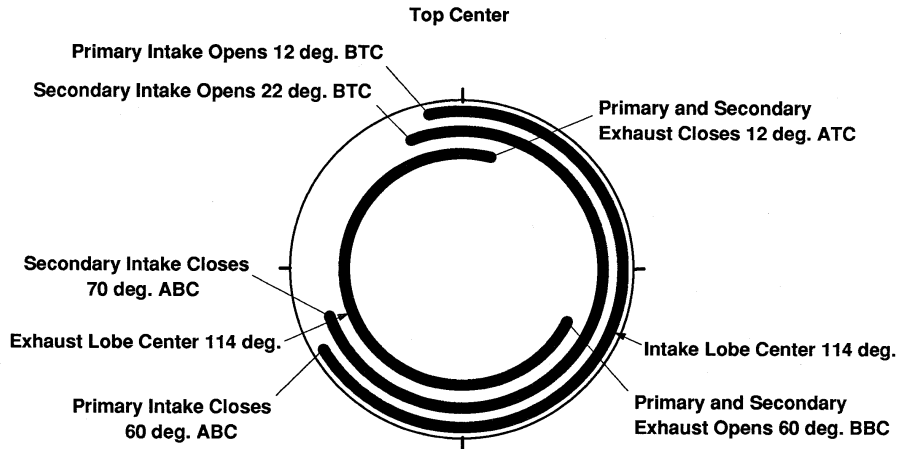
Camshaft Event Timing '90 - '92 LT5

Durations:
 Primary Intake. 252 Degrees. The Lift at All Lobes is .390 Inch.
 Secondary Intake. 272 Degrees.
 Primary and Secondary Exhaust. 252 Degrees. MH 3-97

Measurement Points Are Just Off of the Base Circle. The Total Duration is Shown.

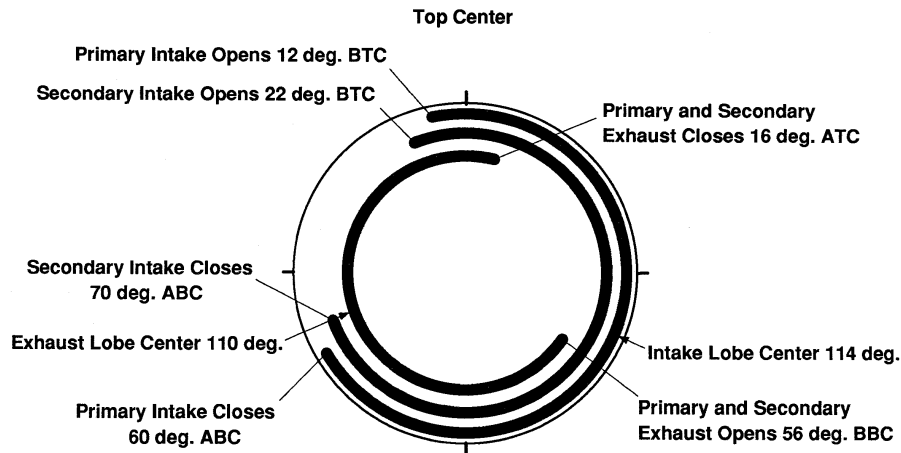
Camshaft Event Timing '93 - '95 LT5

Durations:
 Primary Intake. 252 Degrees. The Lift at All Lobes is .390 Inch.
 Secondary Intake. 272 Degrees.
 Primary and Secondary Exhaust. 252 Degrees. MH 3-97

Measurement Points Are Just Off of the Base Circle. The Total Duration is Shown.

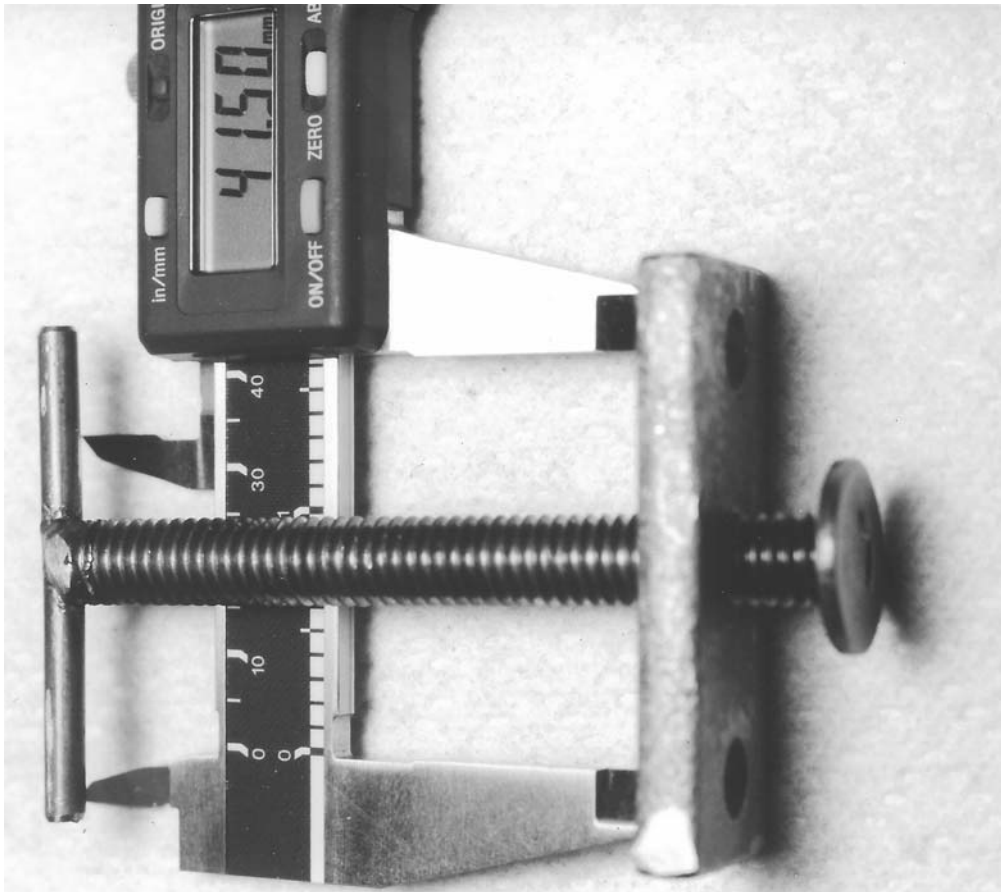
The Manual Timing Chain Tensioner

When measuring the timing, a manual tensioner must be used to control the slack in the chain. The GM tool is J37305. A manual tensioner can be easily made out of a steel bar and a threaded rod. An example is shown below. Install manual tensioners on both banks. Tighten them finger tight with the small wings.

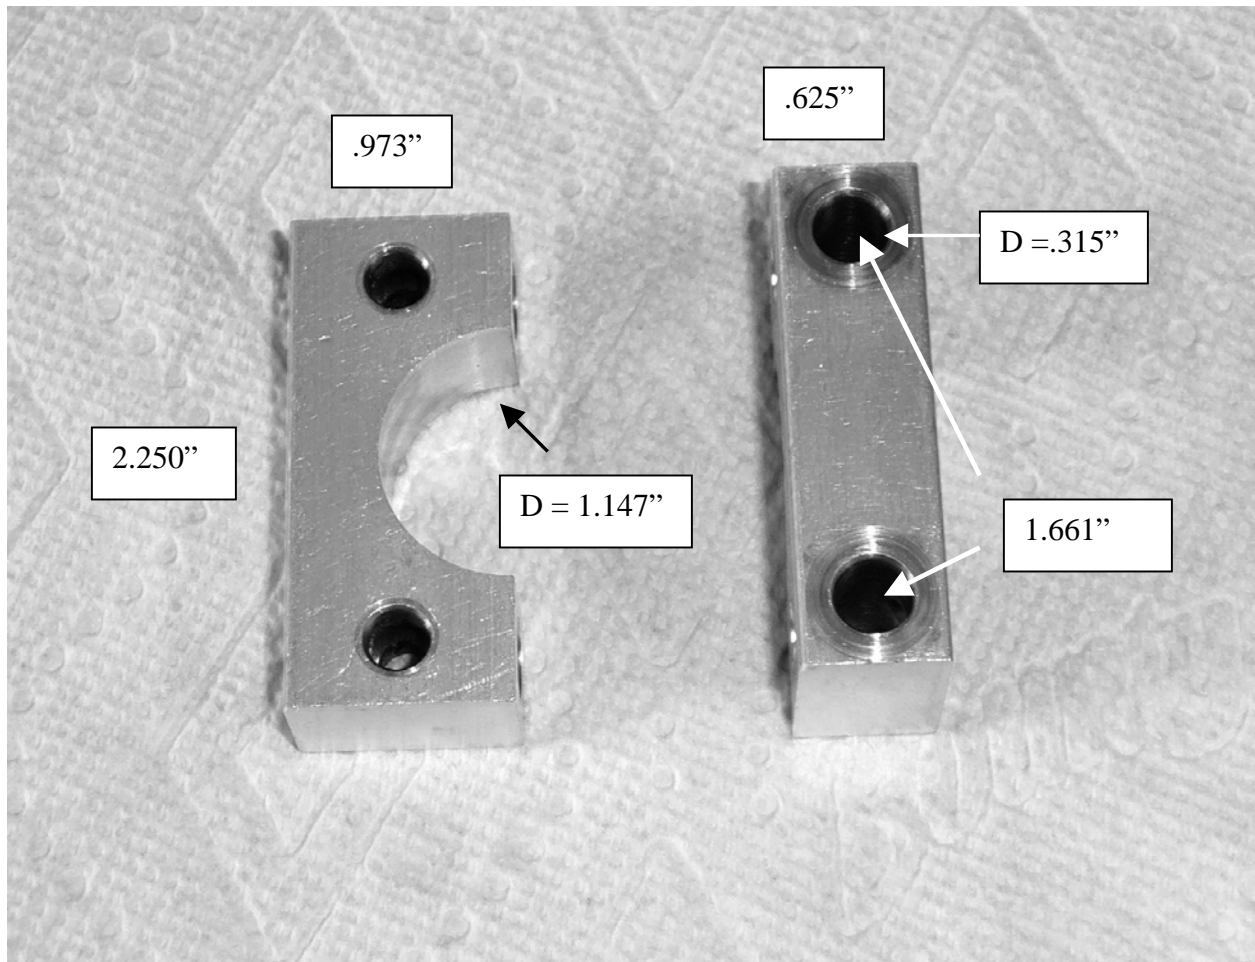
Install Camshaft Hold-Downs

The OE camshaft hold-downs have about .008" camshaft bearing clearance. This is much looser than the camshaft bearing clearance when the camshaft cover is in place. For greater accuracy the camshafts should be held down closer to the normal bearing clearance. The GM tool is J37303. It's easy to have a machinist fabricate camshaft hold-downs. Eight hold-downs are needed. These are the dimensions:
