My Experience With LT5 Oil Consumption 24-Nov-12

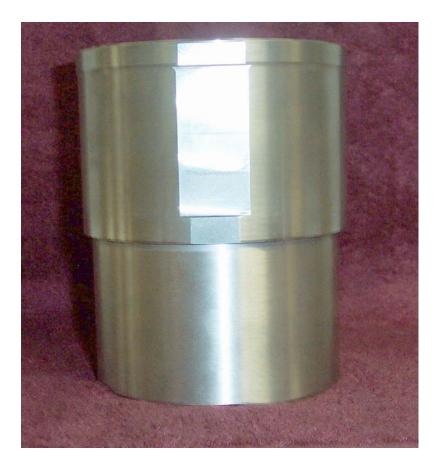
The Nicasil coated aluminum cylinder liner on the OE LT5 is a drop-in wet liner. The outside diameter of the cylinder liner does not receive support from the block.

The top half of the liner is thicker than the bottom half so thermal and mechanical loads on the liner cause it to expand and contract different amounts between the top and the bottom. The liners are from Mahle in Germany. The liners were dropped into the block during the assembly. The cylinder heads clamp the liners into the block. It is not possible to hone a Nicasil bore so the liners can't be finished for best straightness after they are clamped in the block.

Engines that are modified with iron liners can be honed with deck plates to obtain a straighter and rounder finish than the OE liners. Iron liners are used in 368 and 415 ci engines. Honing is complicated because of the step in liner thickness at the center of the liner. If the honing heat is kept low and the liners are finished asymmetrically, they can be made straighter and rounder than the OE liners. An engine with correctly finished iron liners will have better oil control than an OE engine.
